FLOOD CONTROL WORK PLAN  
AREA A7

SANTA YNEZ RIVER, CALIFORNIA

June 1946

## PLATE III PURISIMA CREEK WORK PLAN AREA "A7a" SANTA YNEZ RIVER FLOOD CONTROL PROJECT

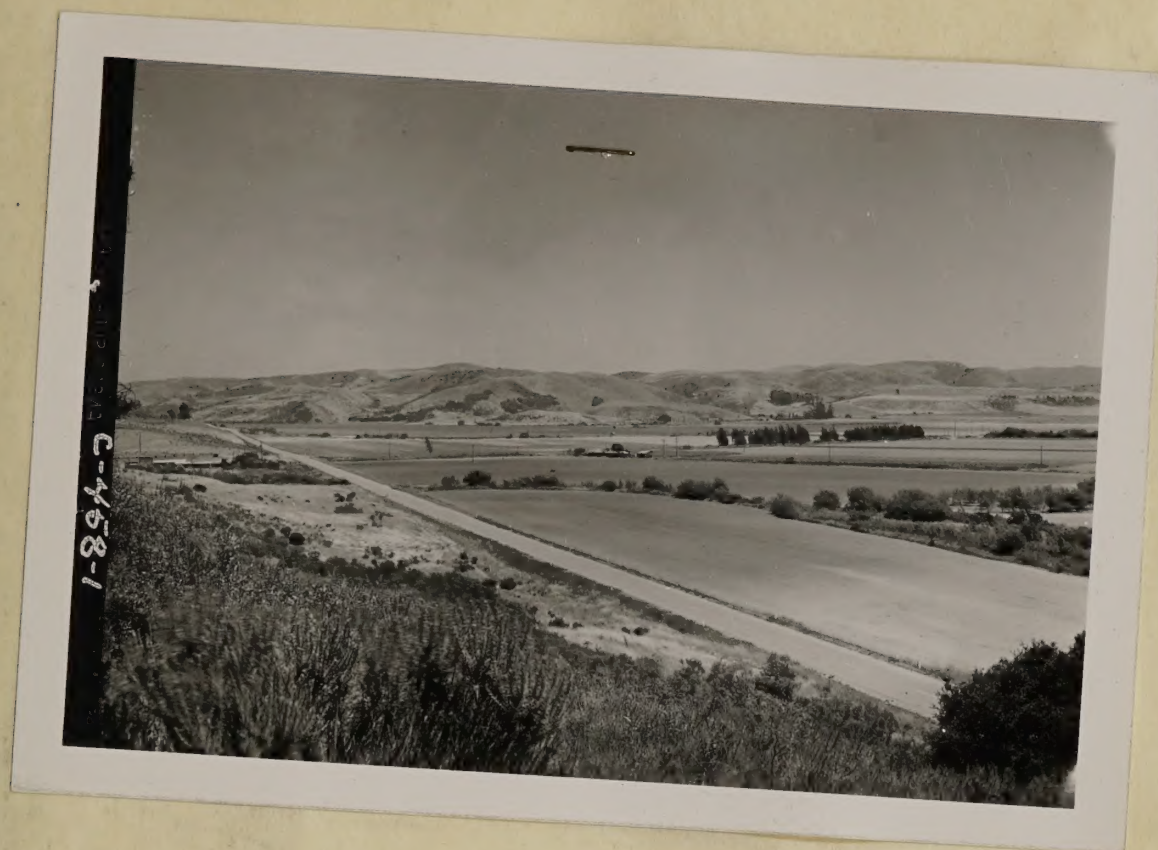
Figure 1

A panorama view of Four Corners deposition area.  
Purisima deposition (light area) in right foreground.  
Cebada and East Cebada deposition in center background.

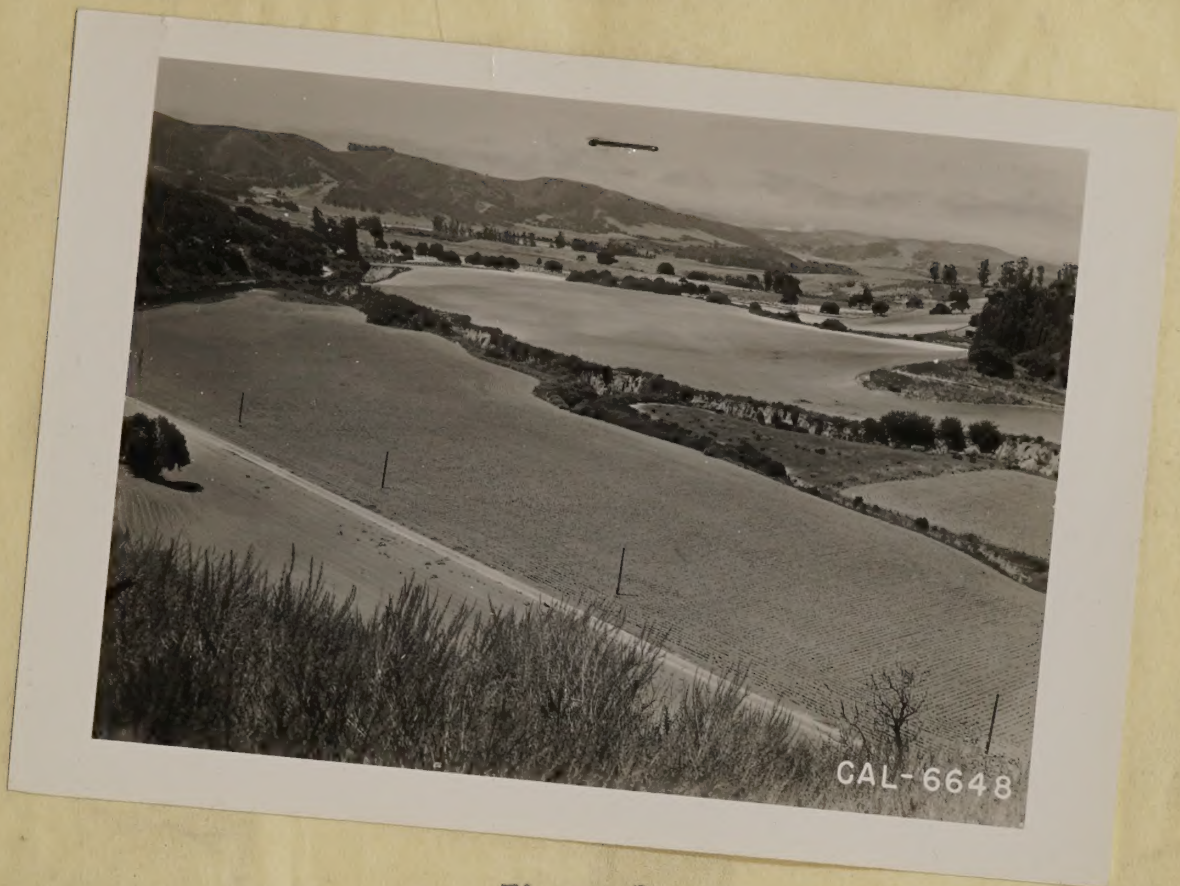
Figure 3  
Typical canyon bottom dry-farmed land cut by deep barranca.  
Recommend: Improved crop rotations, crop residue utilization, diversion terraces and special tillage practices.

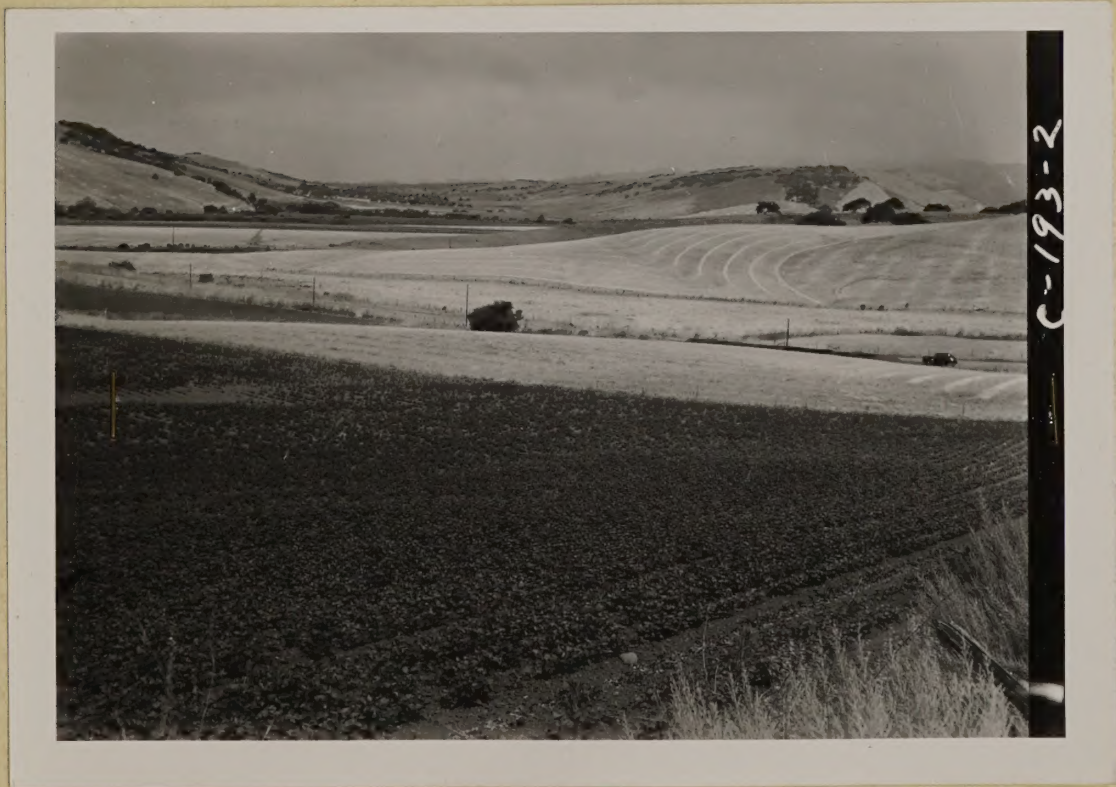
Figure 4  
Dry-farmed hillside cropland. Lima beans in foreground and grain in background.  
Recommend: Change in land use to perennial hay or pasture.

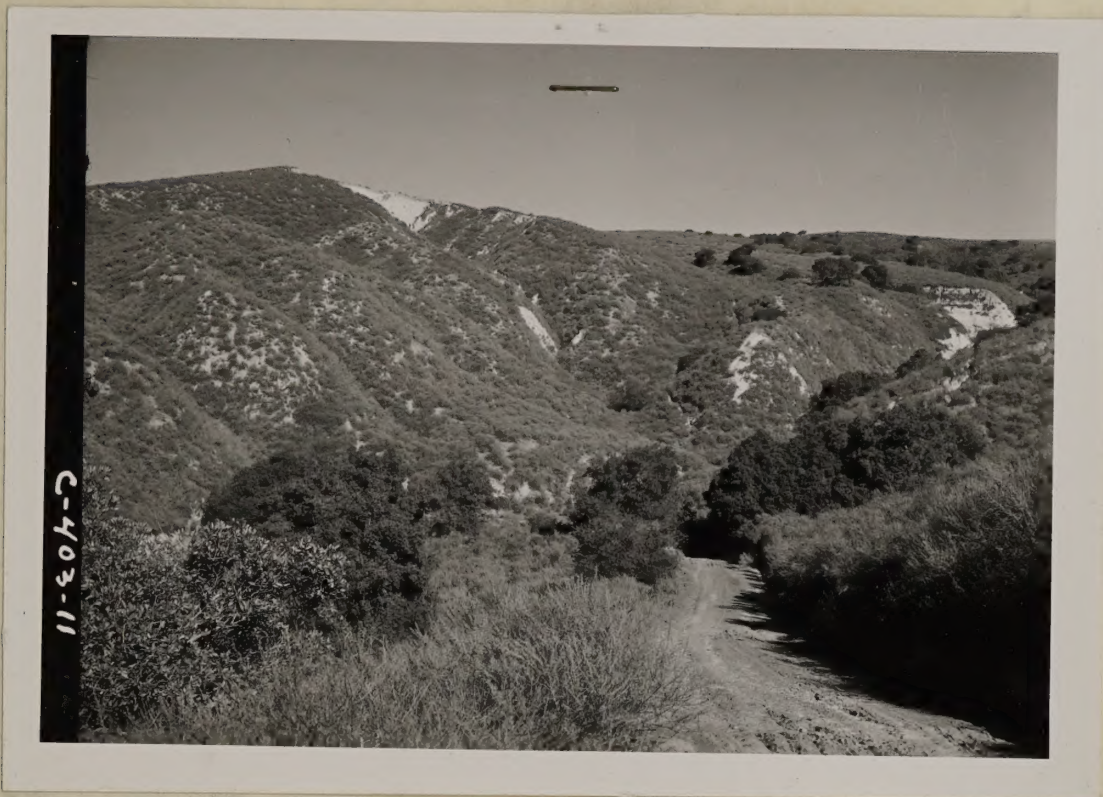
Figure 5

Brush covered hills typical of the upper watershed area. Notice bare raw spots testifying to the instability of the soil.

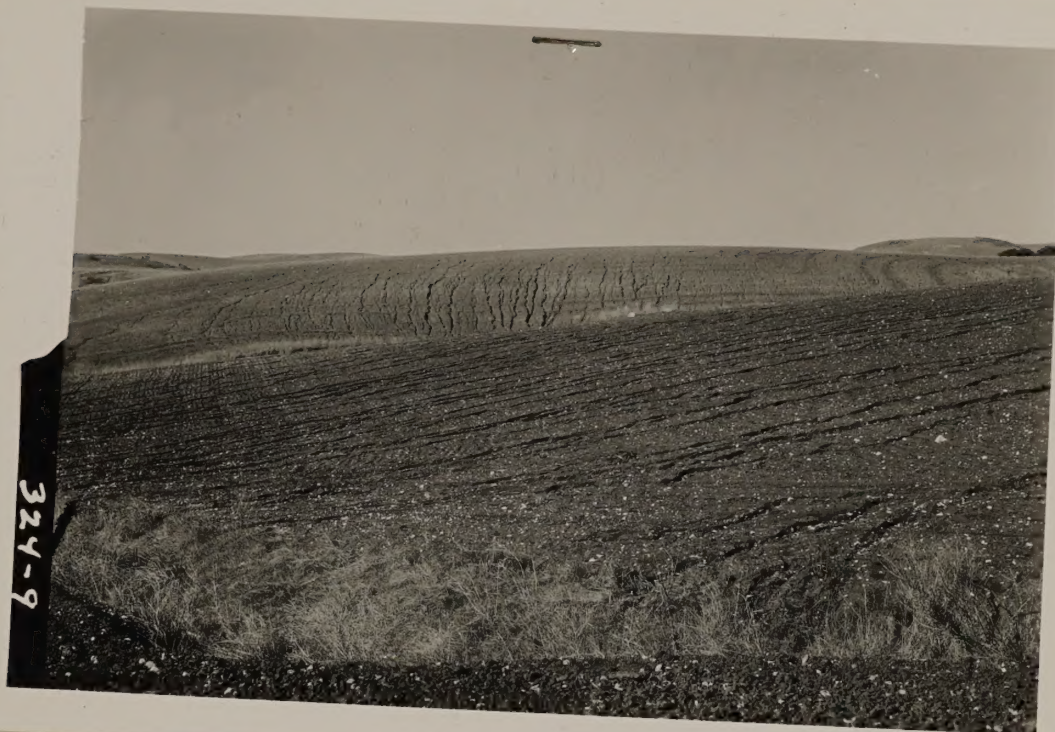
Figure 7

The most severe sheet and gully erosion occurs on Class IV, VII, and VIII dry farmed, hillside cropland where predominately soil depleting crops such as beans and mustard are grown. (See Figure 7) Climatic conditions in this area are very favorable to the production of lima beans which, compared to other adaptable dry land crops, have a high value. Climate and crop then have been of prime consideration in determining land use of the dry farmed cropland, whereas the widely varied soil and slope conditions of the land have been largely ignored. The practice of cash crop farming, clean cultivation during the winter months and failure to use all crop residues has greatly reduced the infiltration rate of the soils and has increased runoff and erosion. Since little or no organic matter is returned to the soil in bean growing, and because of the fine soils mulch which exists, the soil becomes less permeable and the surface tends to seal over with the first rain of the season. Close growing crops, such as grain or mustard, protect the soil much better than do row crops. However, these crops give only partial protection since vegetation may be limited when the heavy rains occur and only a part of the soil is covered with vegetation and bound by plant roots.

Sheet erosion on winter fallowed hillside lands being prepared for planting beans.

Recommend: Change in land use to perennial hay or pasture.

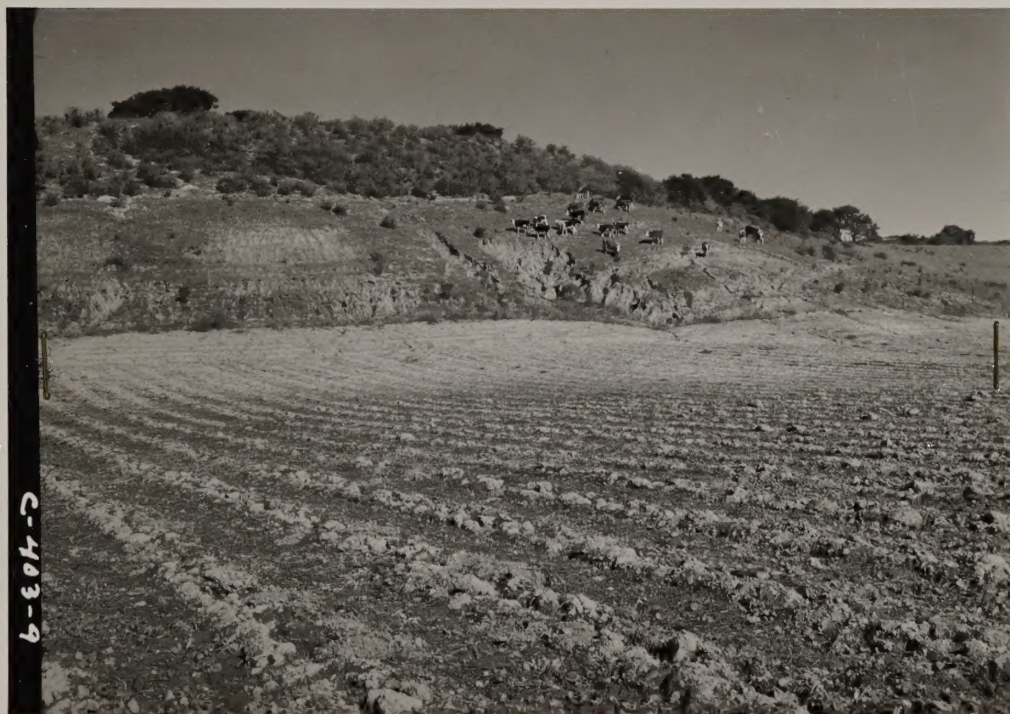
Figure 8

Steep, severely eroded land in background which was once cultivated, but has now been abandoned. Note deposition of sand (light area) at toe of slope.

Recommend: Fencing, mulching and seeding for conversion to non-use.

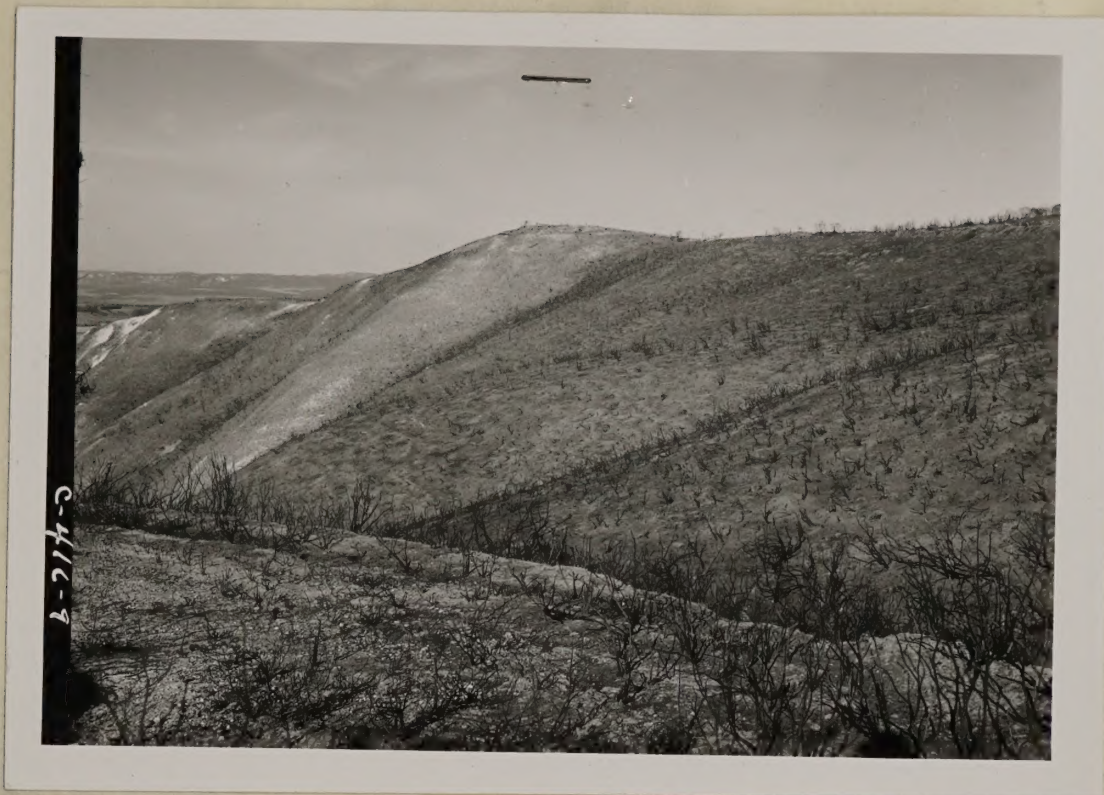
A common practice among livestock owners is to periodically burn off patches of brushlands in an effort to open up areas, destroy ticks and promote the growth of a more desirable type of forage plants. (See Figure 9) This practice does make the areas more accessible and reduces the tick problem, but increase in forage is negligible. Such a practice temporarily denudes the areas, thus promoting increased runoff and erosion until such time that vegetation is reestablished.

Figure 9  
Steep hill lands showing burned over brush lands.  
Recommend: Discontinue burning.

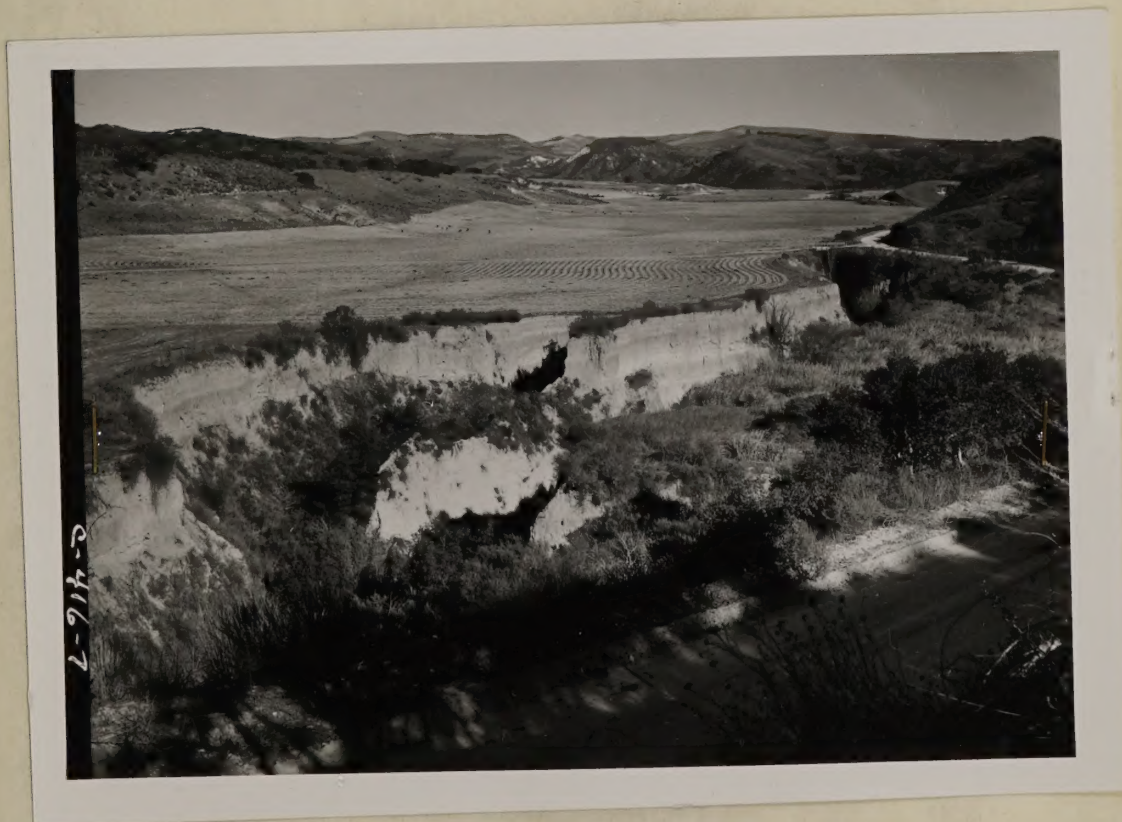
Figure 10  
Cebada canyon barranca showing head and side cutting  
into canyon bottom bean land.

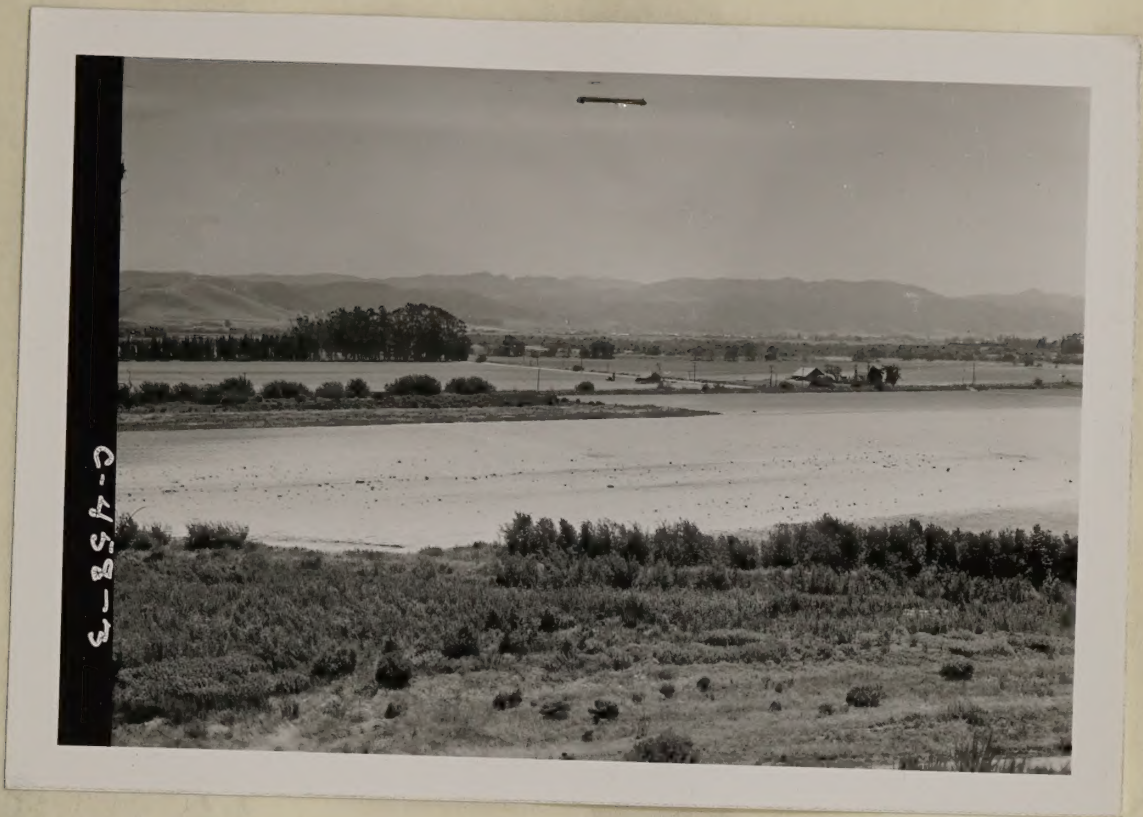
The main deposition of silt from Purisima, Cebada, and East Cebada occurs in an area known as the Four Corners, located one-half mile south of the La Purisima Mission and three miles northeast of Lompoc. Field observation and measurement indicates that there are 760 acres of fertile, high productive land in the Four Corners area that are subject to deposition. Of this area, 420 acres have been damaged to the extent of having deposition of infertile sand of six inches to six feet. (See Figure 11)

Figure 11  
Four Corners area showing deposition of infertile sand.

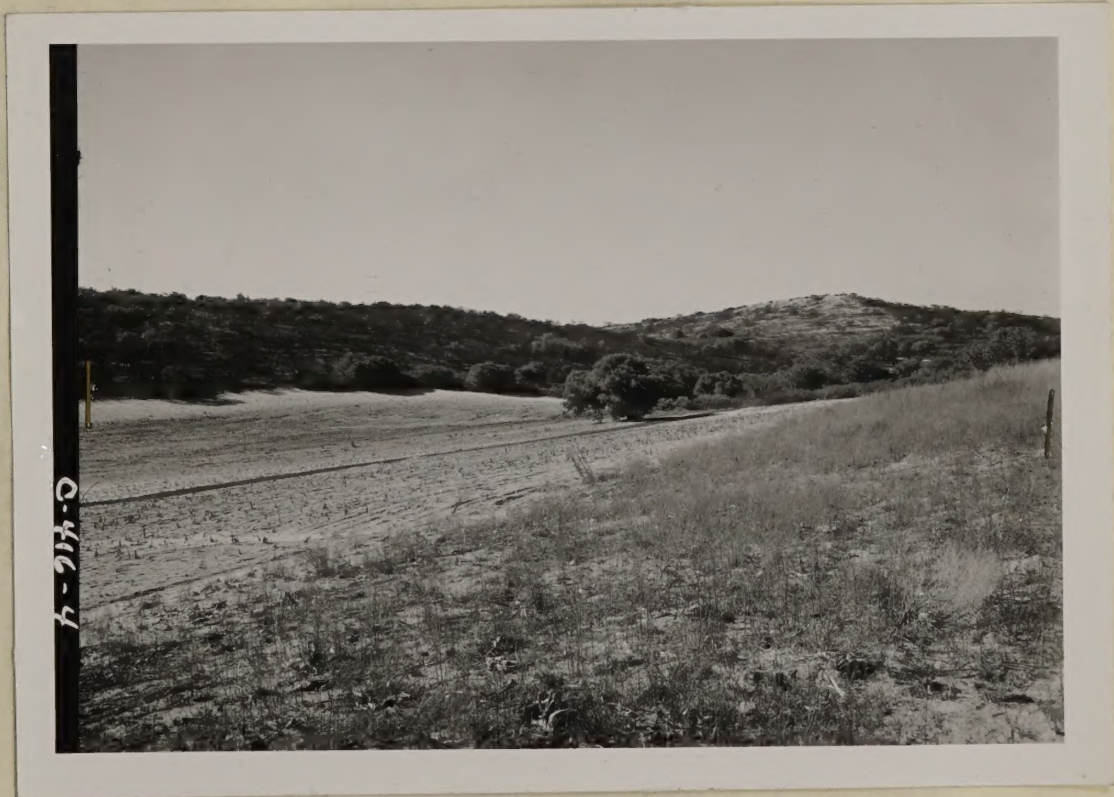
Figure 12  
Typical sandy, infertile hillside cropland. Note sparse vegetative cover.  
Recommend: Planting of cover crop for watershed protection and conversion to non-use.

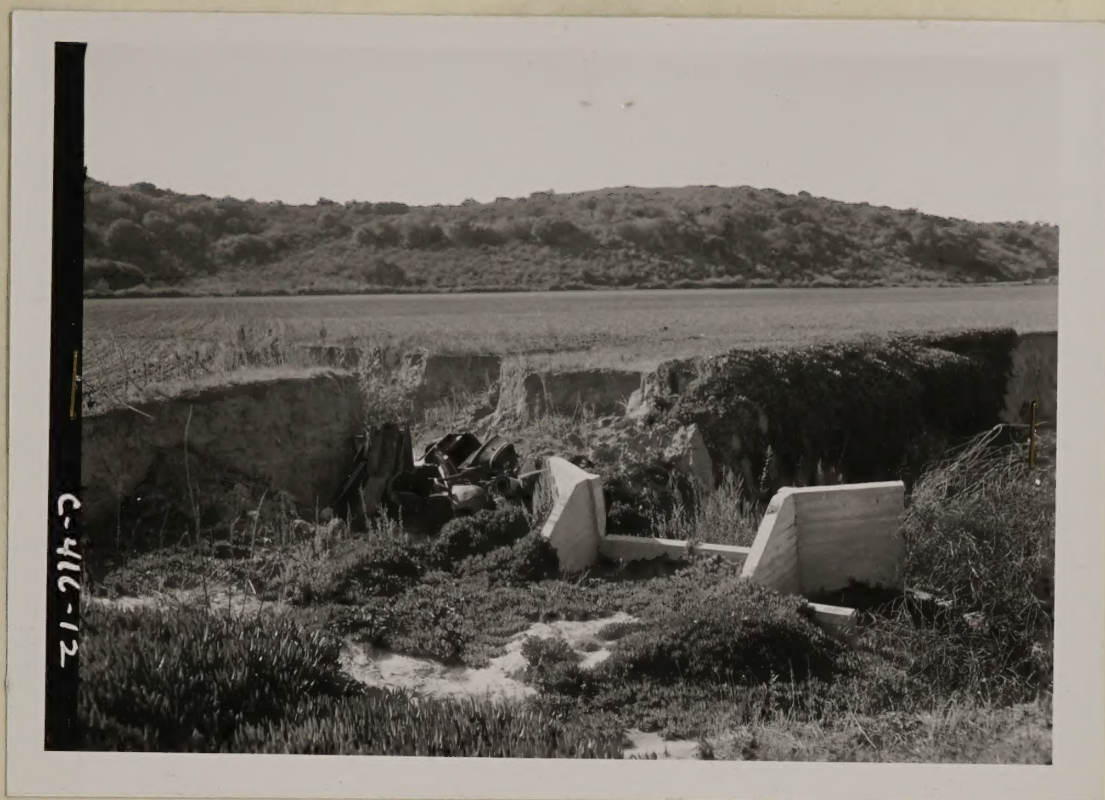
Figure 13

Failure of concrete check dam in Purisima Canyon. Dam failure was caused by failure of terrace outlet structure. Grade recession along terrace can be seen in left center. Proper maintenance of terrace outlet would have avoided this failure.

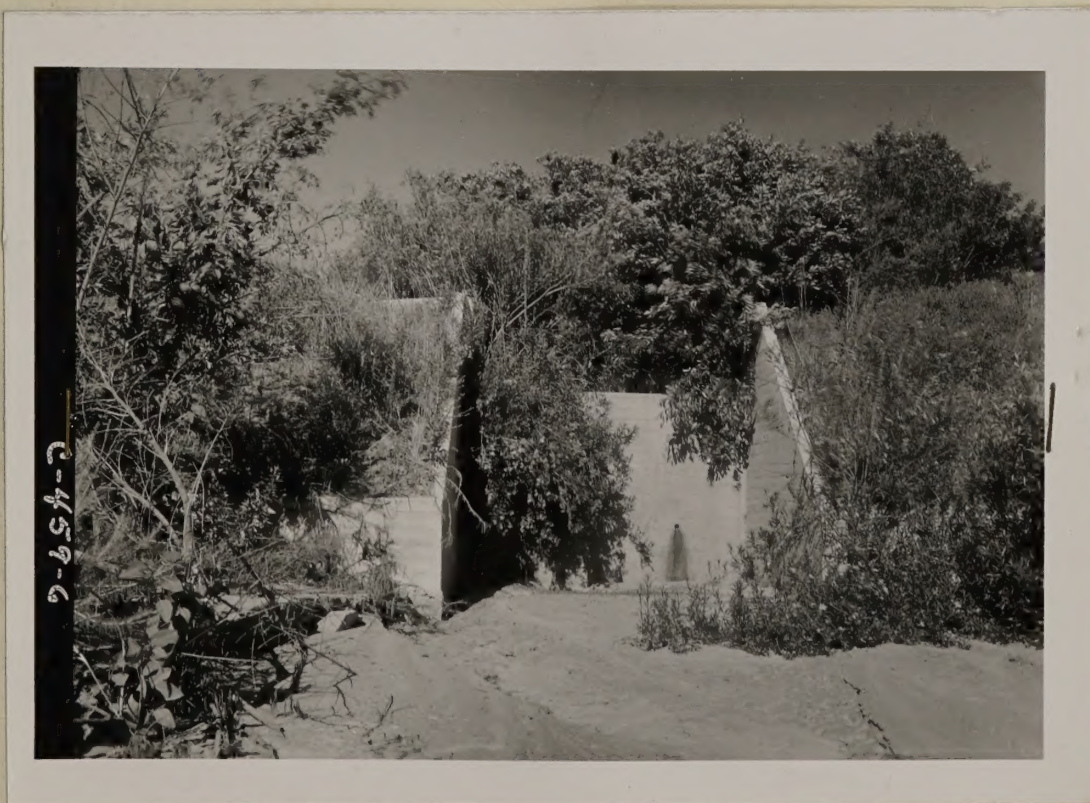
Figure 14

Concrete check dam choked with vegetation. Capacity of structure is materially reduced. Periodic maintenance is necessary to avoid failure.

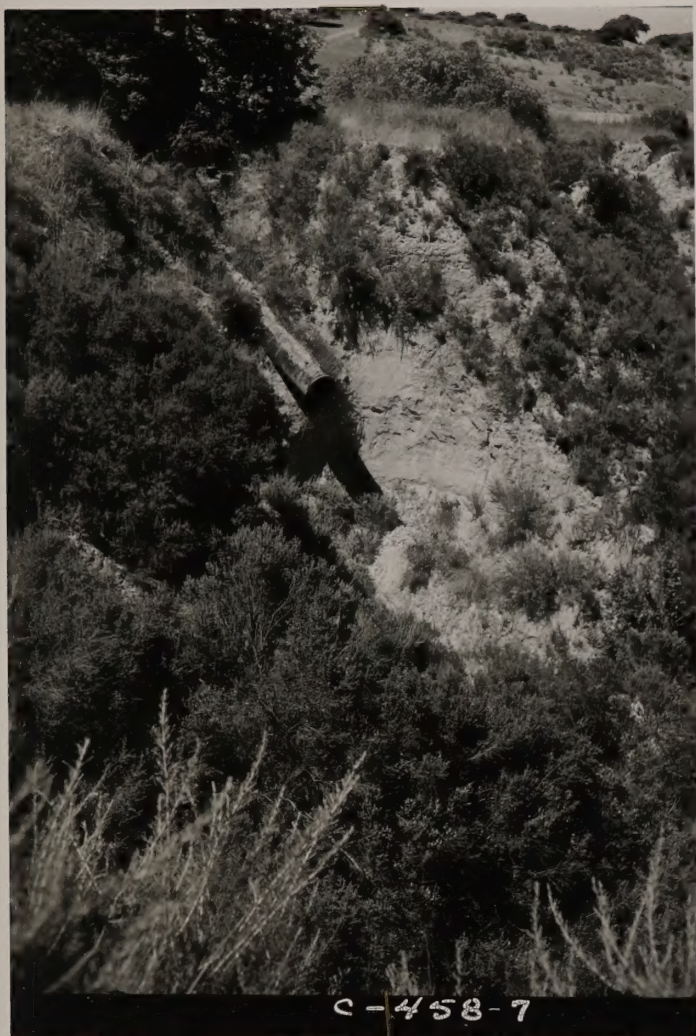
Figure 15  
Head control structures in  
Cebada Canyon. Recommended  
for replacement with structure  
No. A7b6-1.1. (See Plate II).

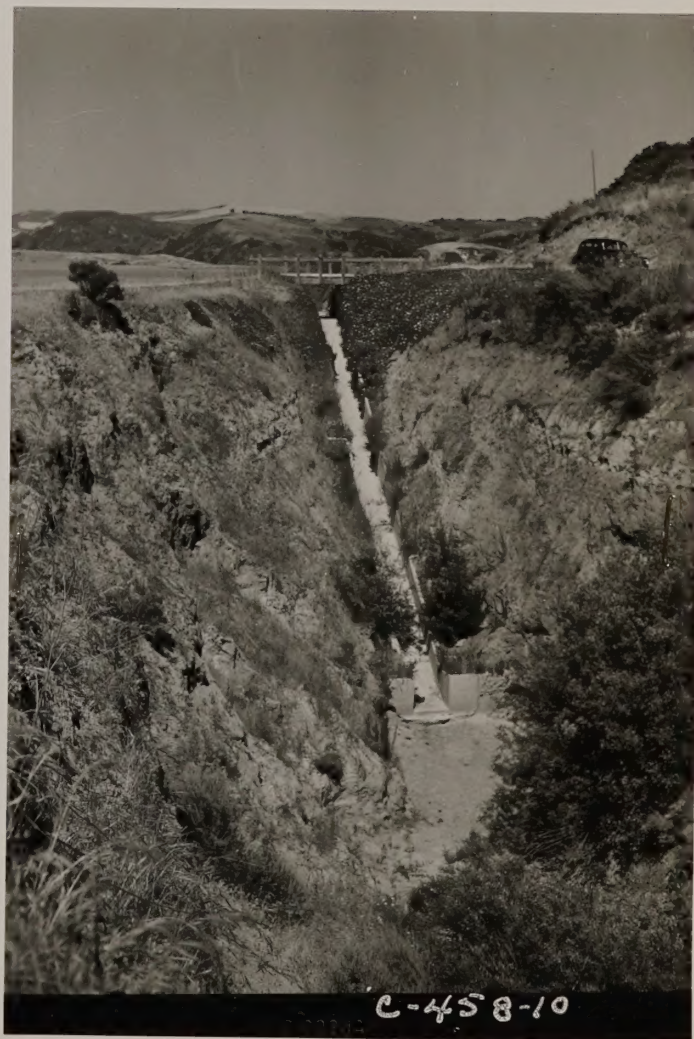
Figure 18

Head control structure in  
Cabrera Canyon. Recommended  
for replacement with structure  
No. AV06-1.1. (See Plate II).

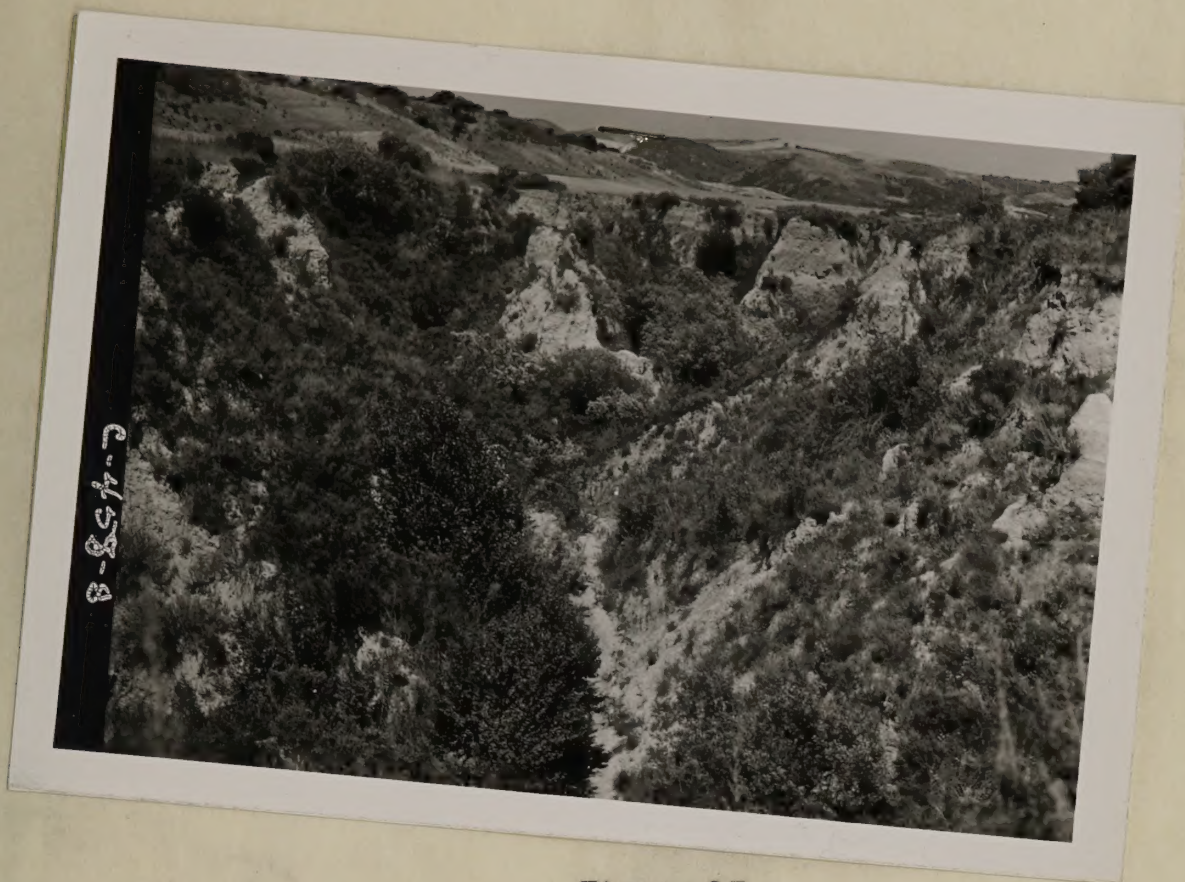
Figure 17  
Cebada Canyon at upper dam site. Structure  
No. A7b3-1.2 recommended at this location.

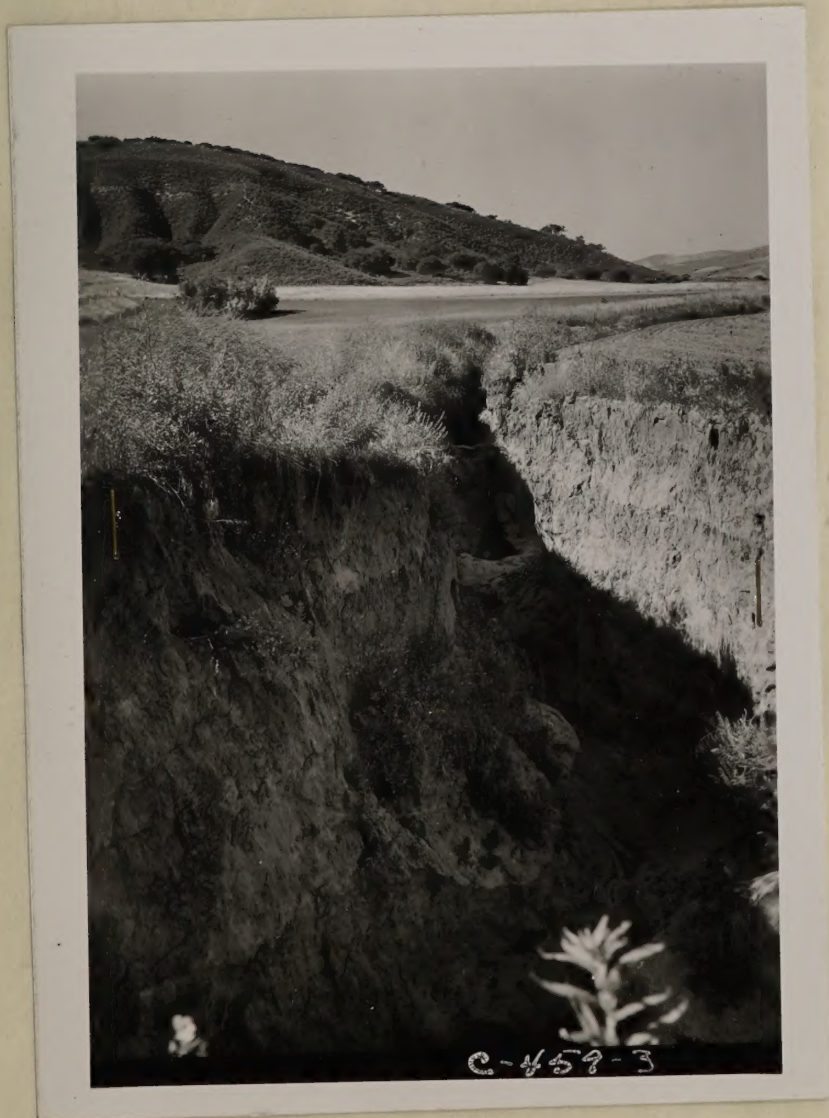
Figure 18  
Typical field gully showing  
active head cutting. Pipe  
overfall structures are recom-  
mended for these locations.

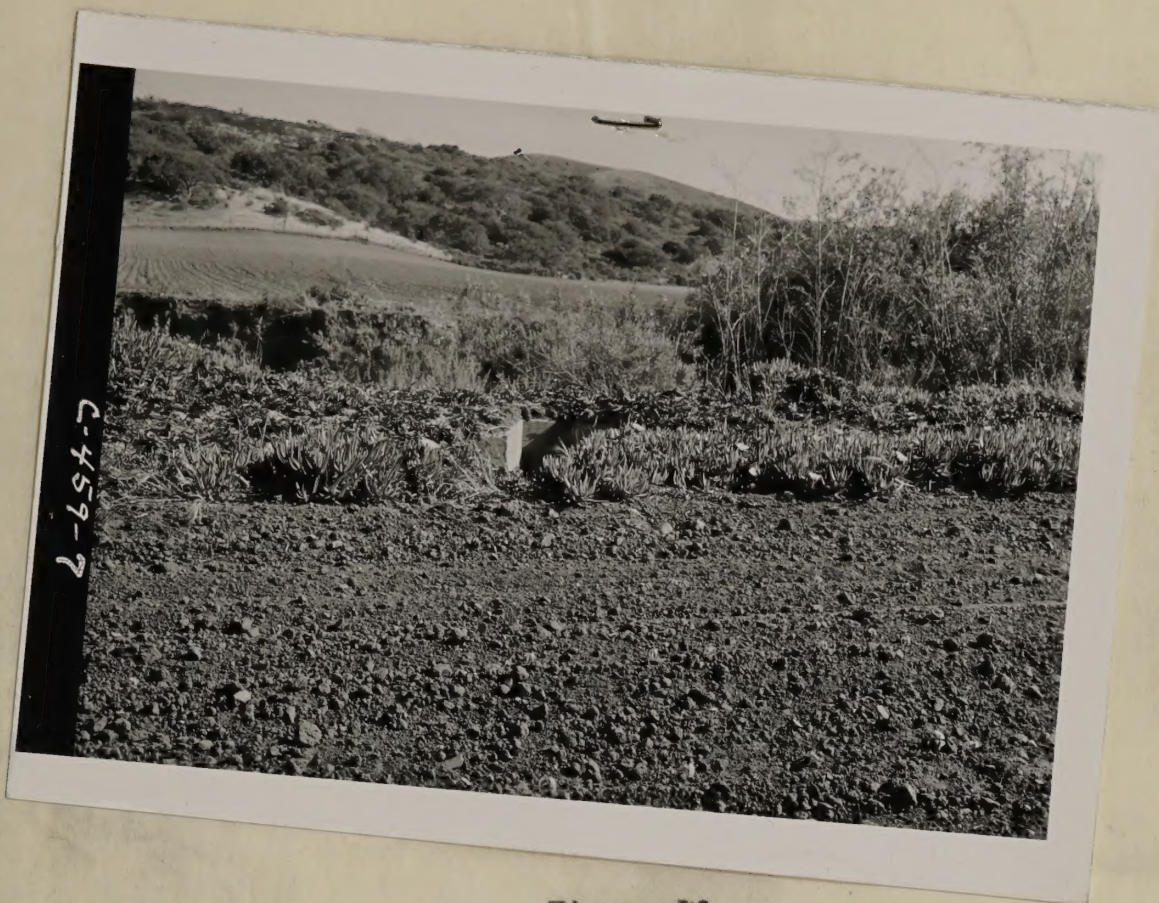
Figure 19

Unmaintained terrace outlet structure showing need for maintenance to insure adequacy of structure.

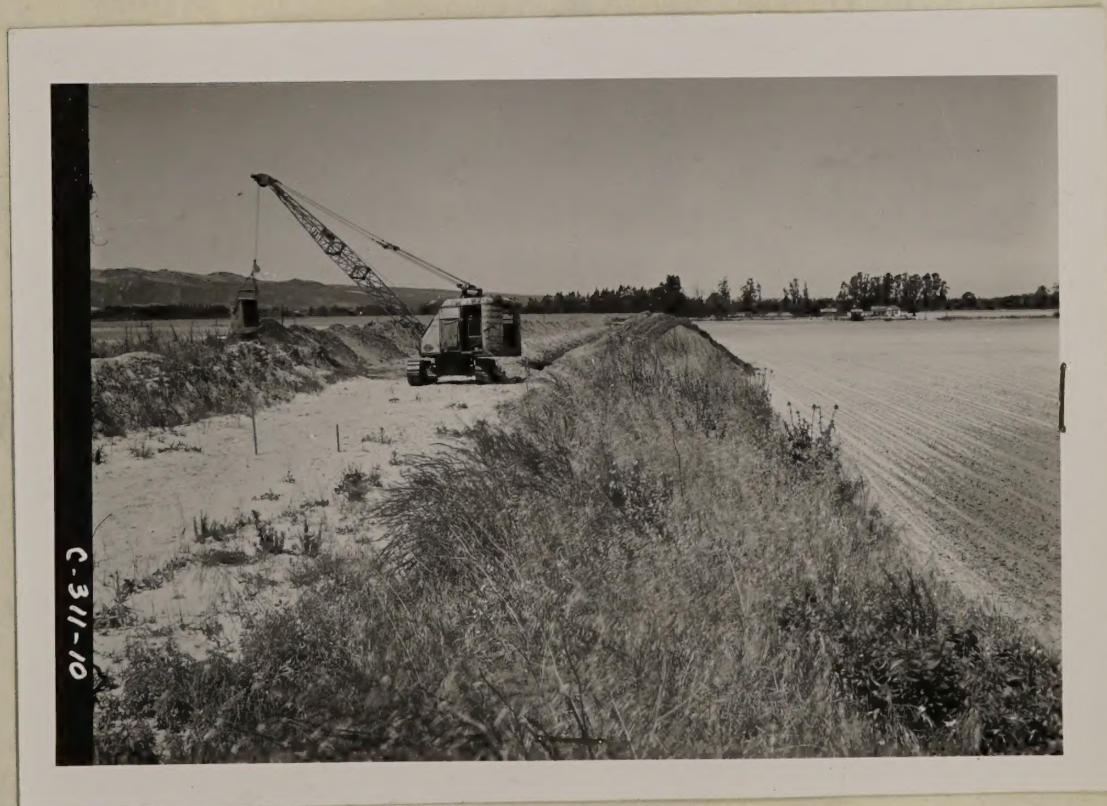
Figure 20

East Cebada Channel reach A7cl-2 (See Plate III) being cleaned by owner. Note silted channel in foreground. Channel banks require revetment in this sandy material.
